# Case Study

Corrizon Base – using outstanding anti-corrosive waterborne coat as part of paint system for maintenance

**Goliath Leader**

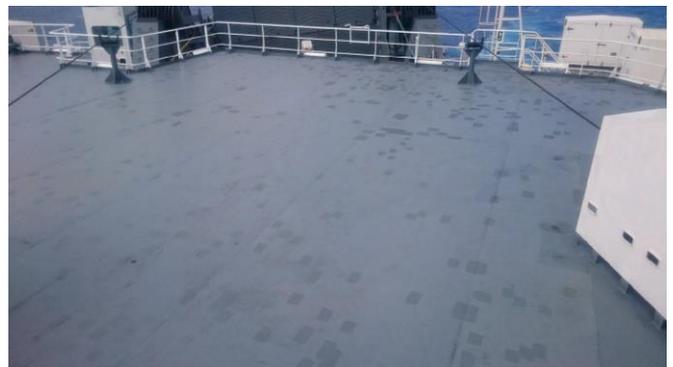
According to the Goliath Leader Captain: *"The Coating is withstanding good and no any further painting or traces of rust observed"*.

Upper deck after treatment

The outdoor surfaces of the vessel were prepared by high pressure (100-200 bars) water cleaning to remove all loose paint, mill scale and rust. Once the surfaces were dry, the crew used a *Corrizon base* coat over the stable rust and old paint. The product has a low VOC (Volatile Organic Compound) level ~0 enabling the crew to work without any special protective equipment even in unventilated areas. In the end, they returned the product to its original package for later additional uses and within 24hrs, they had covered the *Corrizon base* layer with common top paints which are used on vessels.

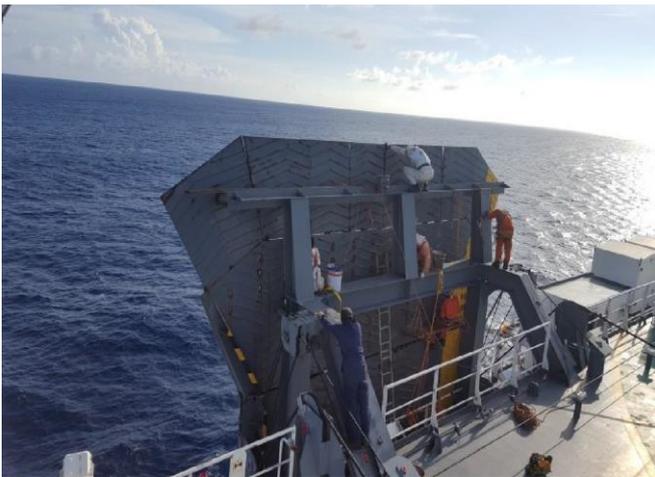
Surface preparation - high pressure water

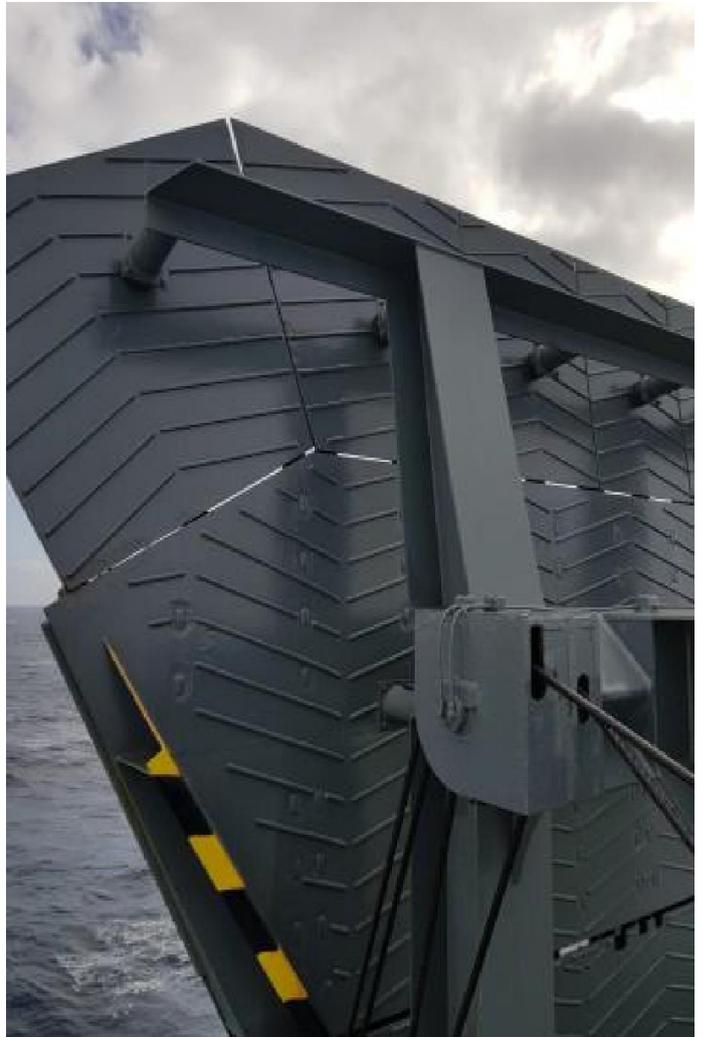
Vehicle carrier side ramp during maintenance
