Case Study

Corrizon Base – using outstanding anti-corrosive waterborne coat as part of paint system for tank floated roof maintenance

**Ponton Floated
roof – Oil Storage
Tank**

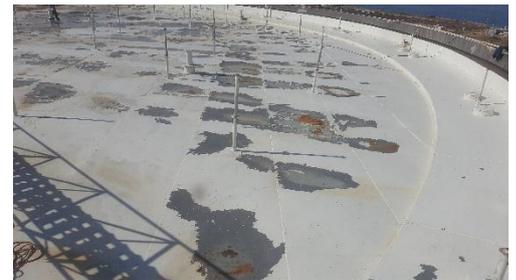
The Client is an energy infrastructures company providing storage and transport services as well as port services for energy products for domestic and foreign customers. The company was established in 1968 and has dozens of large volume steel tanks. The proximity to the seashore and to a coal-based electricity facility are responsible for accelerating the rusting process and for more frequent maintenance.

Floated roof initial condition

The surface of the float roof was cleaned by high pressure water jetting (over 500 bar) to remove old paint and loose metal. Once the area was dry, **Corrizon Base** was applied by airless spray over the old paint. The required WFT was fifty microns. **Corrizon base** has white-off white color (the old top paint was white). A pigment was added to the product to verify that all surfaces had been coated. Twenty-four hours later, a new polyurethane top paint layer was applied to complete the customer paint system requirements. Gloves and protective glasses were the only personal protective equipment required, even respiratory masks were not necessary.

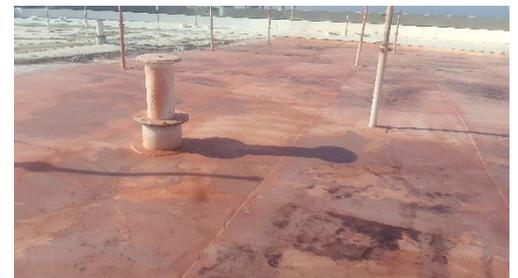
Pigmented Corrizon Base

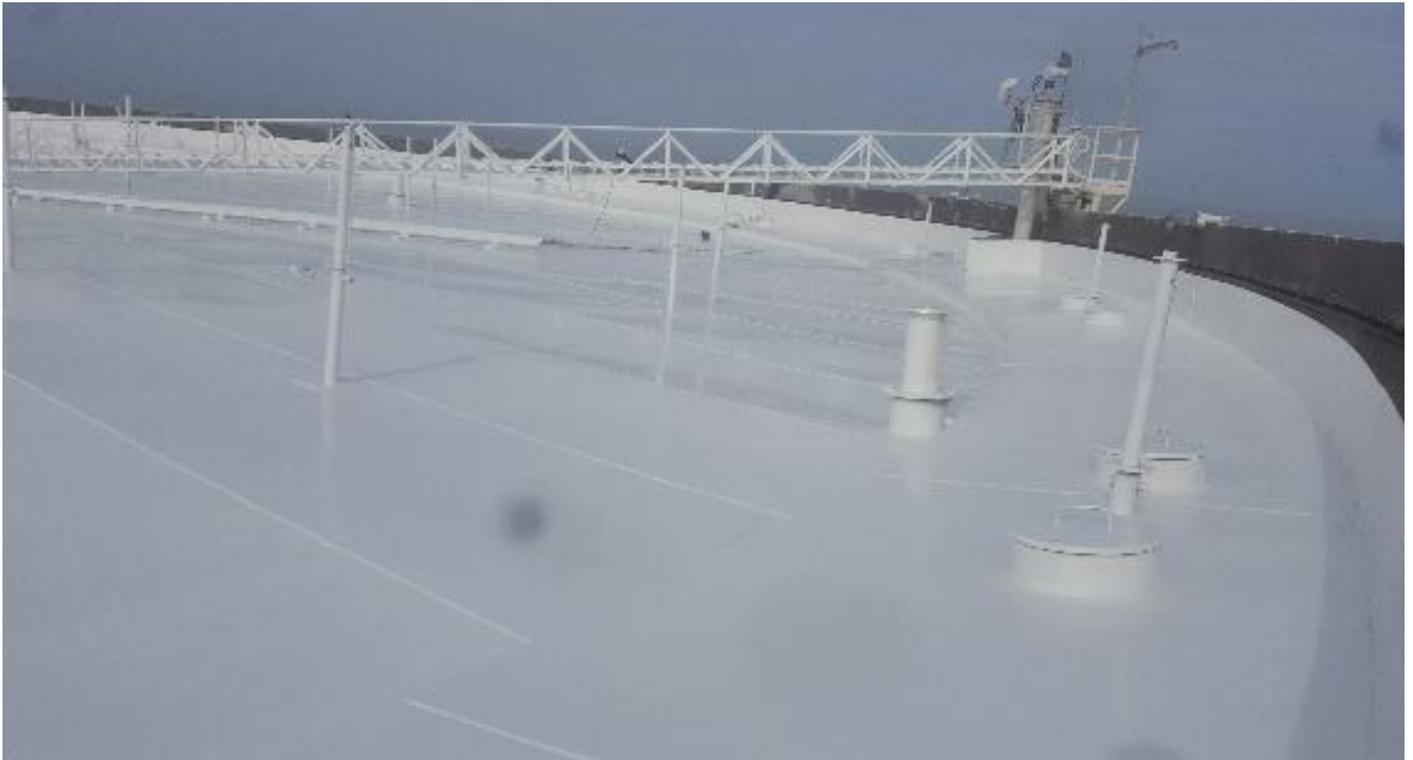
After over a year, the floated roof is in excellent condition. There is no sign of rust or paint lamination. Also, the DFT remains the same and the adhesion is very good.

According to the maintenance manager and the inspector: *"After more than a year, the ponton's roof was inspected and there is no sign of corrosion on the base metal. We also applied it over different surfaces in the plant and the results were also very good".*

Floated roof appearance after polyurethane top paint
